Uniform Mitigation Verification Inspection Form

Inspection Date: 2025-01-13		
Owner Information		
Owner Name:		Contact Person:
Address: (484-504) Bristle Cone Ln		Home Phone:
City: Naples	Zip: 34113	Work Phone:
County: Collier		Cell Phone:
Insurance Company:		Policy #:
Year of Home: 1976	# of Stories: 2	Email:

Wind Mitigation Photos

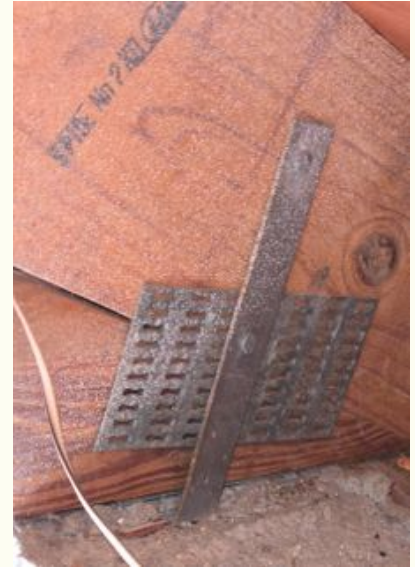
Roof to Wall Attachment (#RWA)

- ☒ A. Toe Nails
 - ☐ Truss/rafter anchored to top plate of wall using nails driven at an angle through the truss/rafter and attached to the top plate of the wall, or
 - ☒ Metal connectors that do not meet the minimal conditions or requirements of B, C, or D

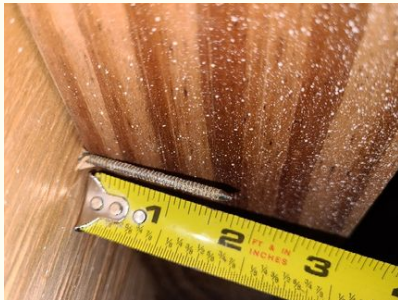
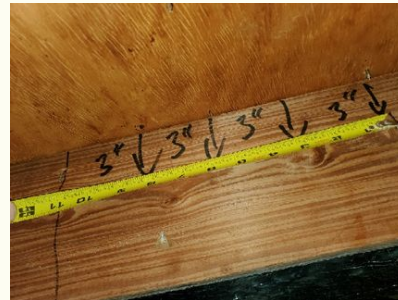
📌 Inspection Notes: **ROOF DECK ATTACHMENT (#RDA)**

- ☒ C. Plywood/OSB roof sheathing with a minimum thickness of 7/16" inch attached to the roof truss/rafter (spaced a maximum of 24" inches o.c.) by 8d common nails spaced a maximum of 6" inches in the field. -OR- Dimensional lumber/Tongue & Groove decking with a minimum of 2 nails per board (or 1 nail per board if each board is equal to or less than 6 inches in width). -OR- Any system of screws, nails, adhesives, other deck fastening system or truss/rafter spacing that is shown to have an equivalent

or greater resistance than 8d common nails spaced a maximum of 6 inches in the field or has a mean uplift resistance of at least 182 psf.
